Unit C Initial Assessment Technical Report on Findings

Unit C Initial Assessment
July 2024

Client name:	Environment Agency	Project no:	B550C0AG
Project name:	Unit C Initial Assessment	Project manager:	Kamil Muniak
Client reference:	[Client reference]	Prepared by:	Kevin Burgess and Beatriz Serato
Document no:	01	File name:	Unit C_InitialAssessment_FINAL_25Jun24
Version:	02		
Date:	July 2024

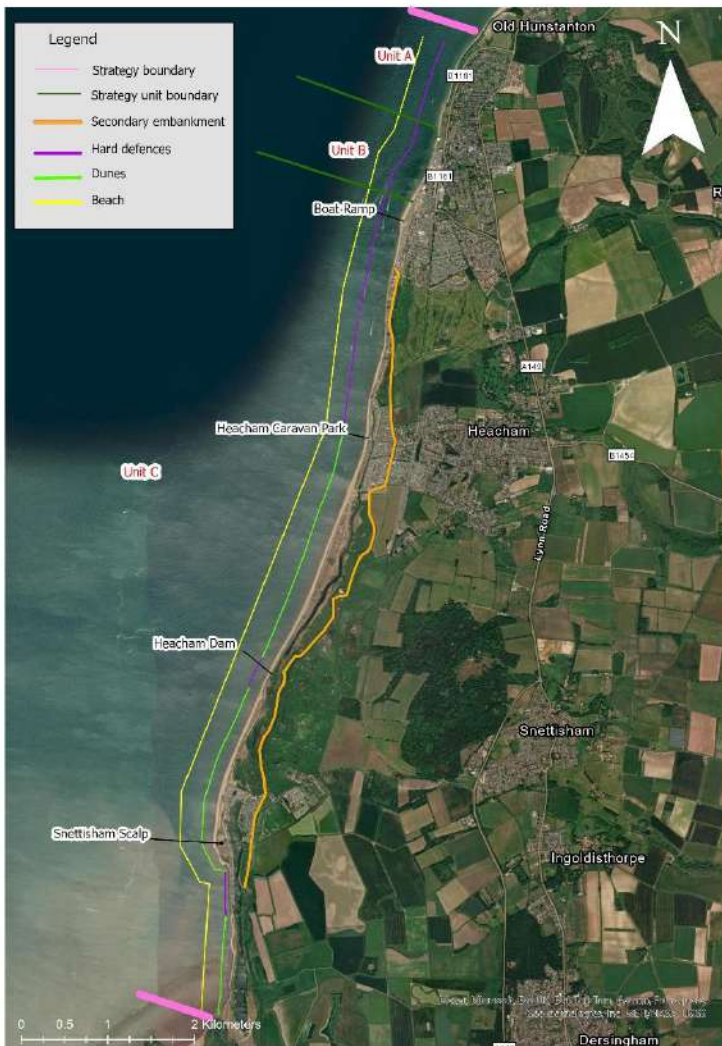
Figure 1-1 Strategy unit boundaries and features along the frontage

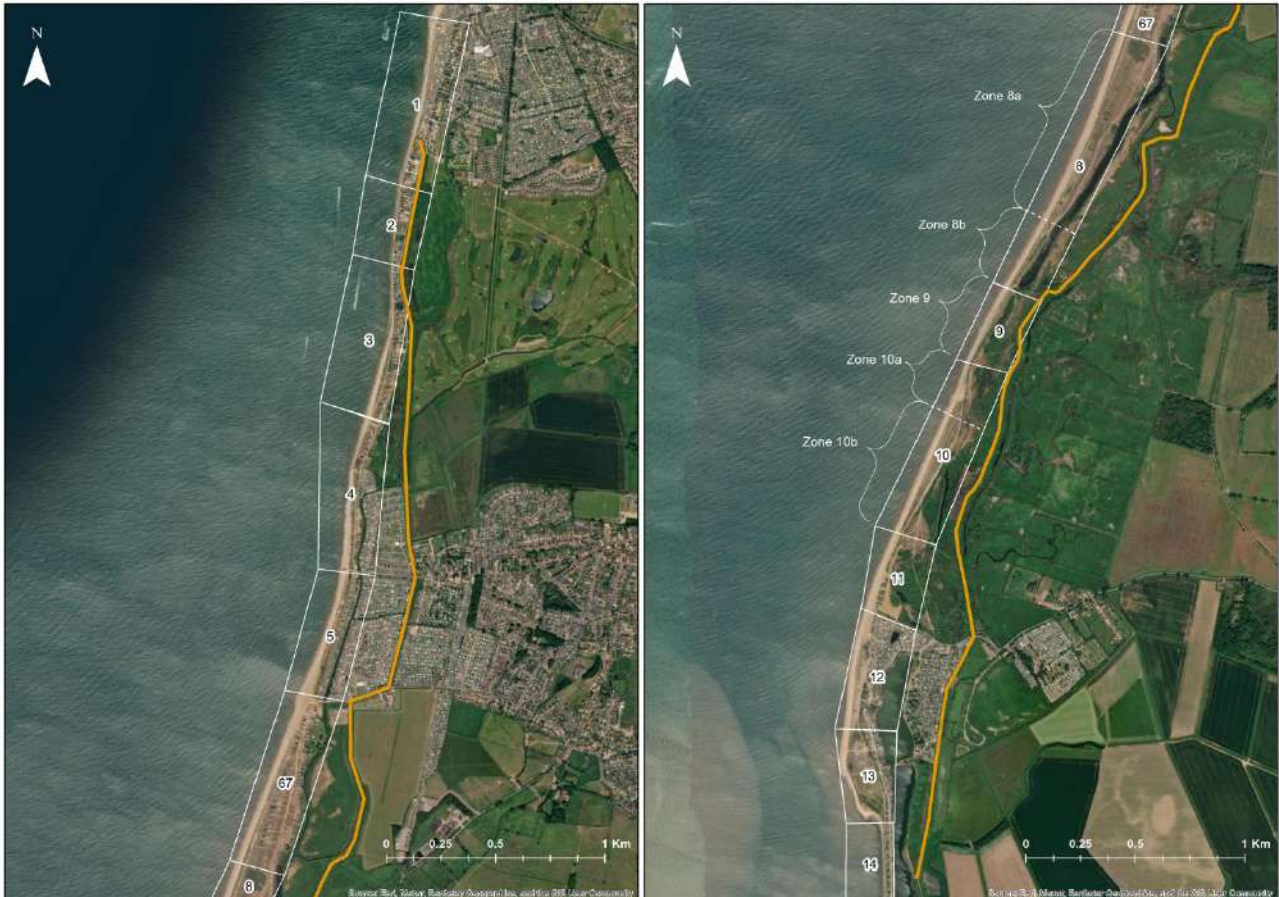
Figure 2-1: Frontage (Unit C) with the Zones marked on there and showing the secondary bank (in orange location approximate).

This assessment covers the area currently managed by the Environment Agency, from the Power Boat Ramp to the end of the Snettisham Scalp (Figure 2-1). This has previously been considered with reference to a number of 'zones' along the frontage, which are used again in this report and shown on the figure below. The whole frontage (from Zones 1 to 15) is backed by a secondary flood defence in the form of a grassed earth embankment set back a short distance.

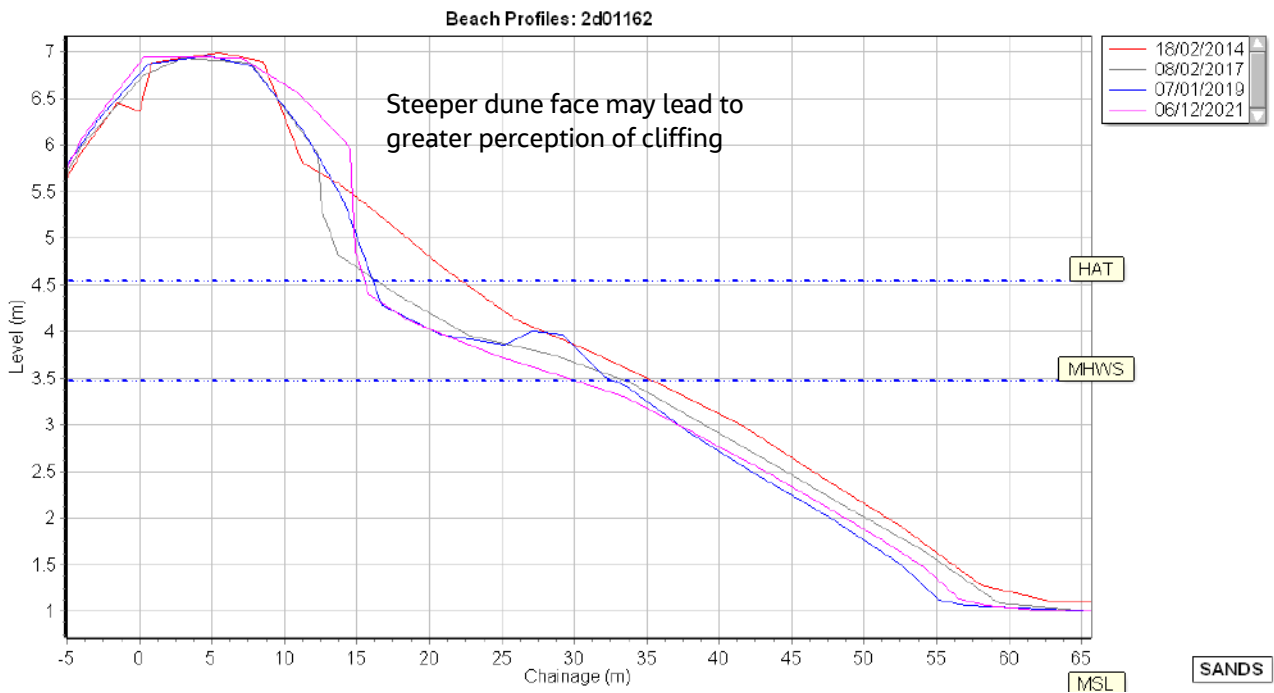
Figure 4-6: Profile 2d01162 within Zone 11, showing beach topographic surveys between 2014 and 2021. (Dec 2021 represents the pre-recycling survey of 2022)

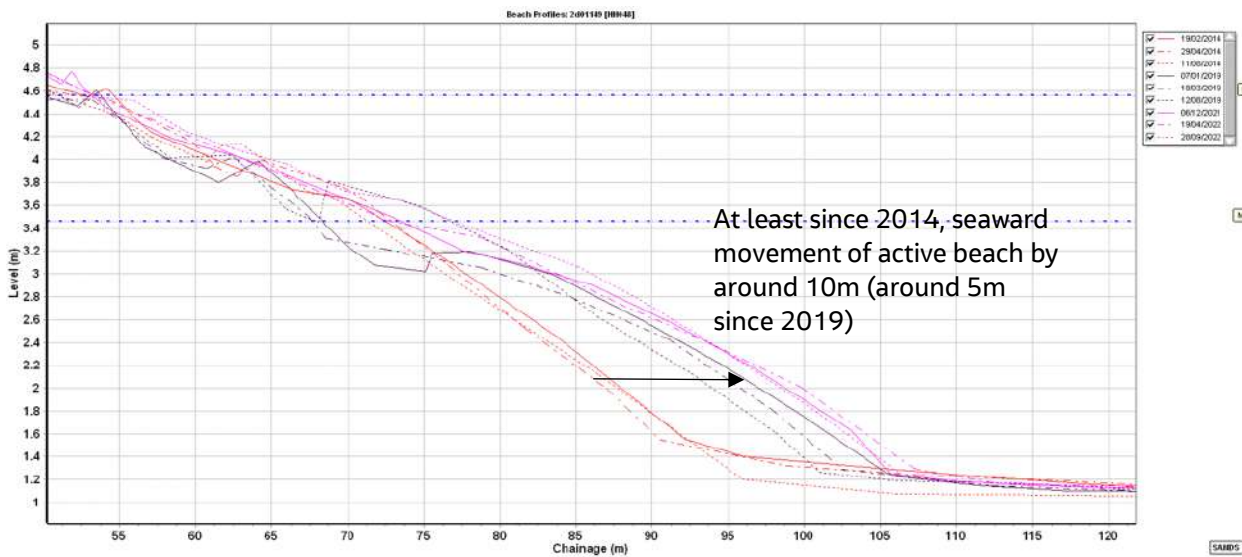
Figure 4-8: Profile 2d01149 within Zone 13, showing profiles in 2014, 2019 and 2022.

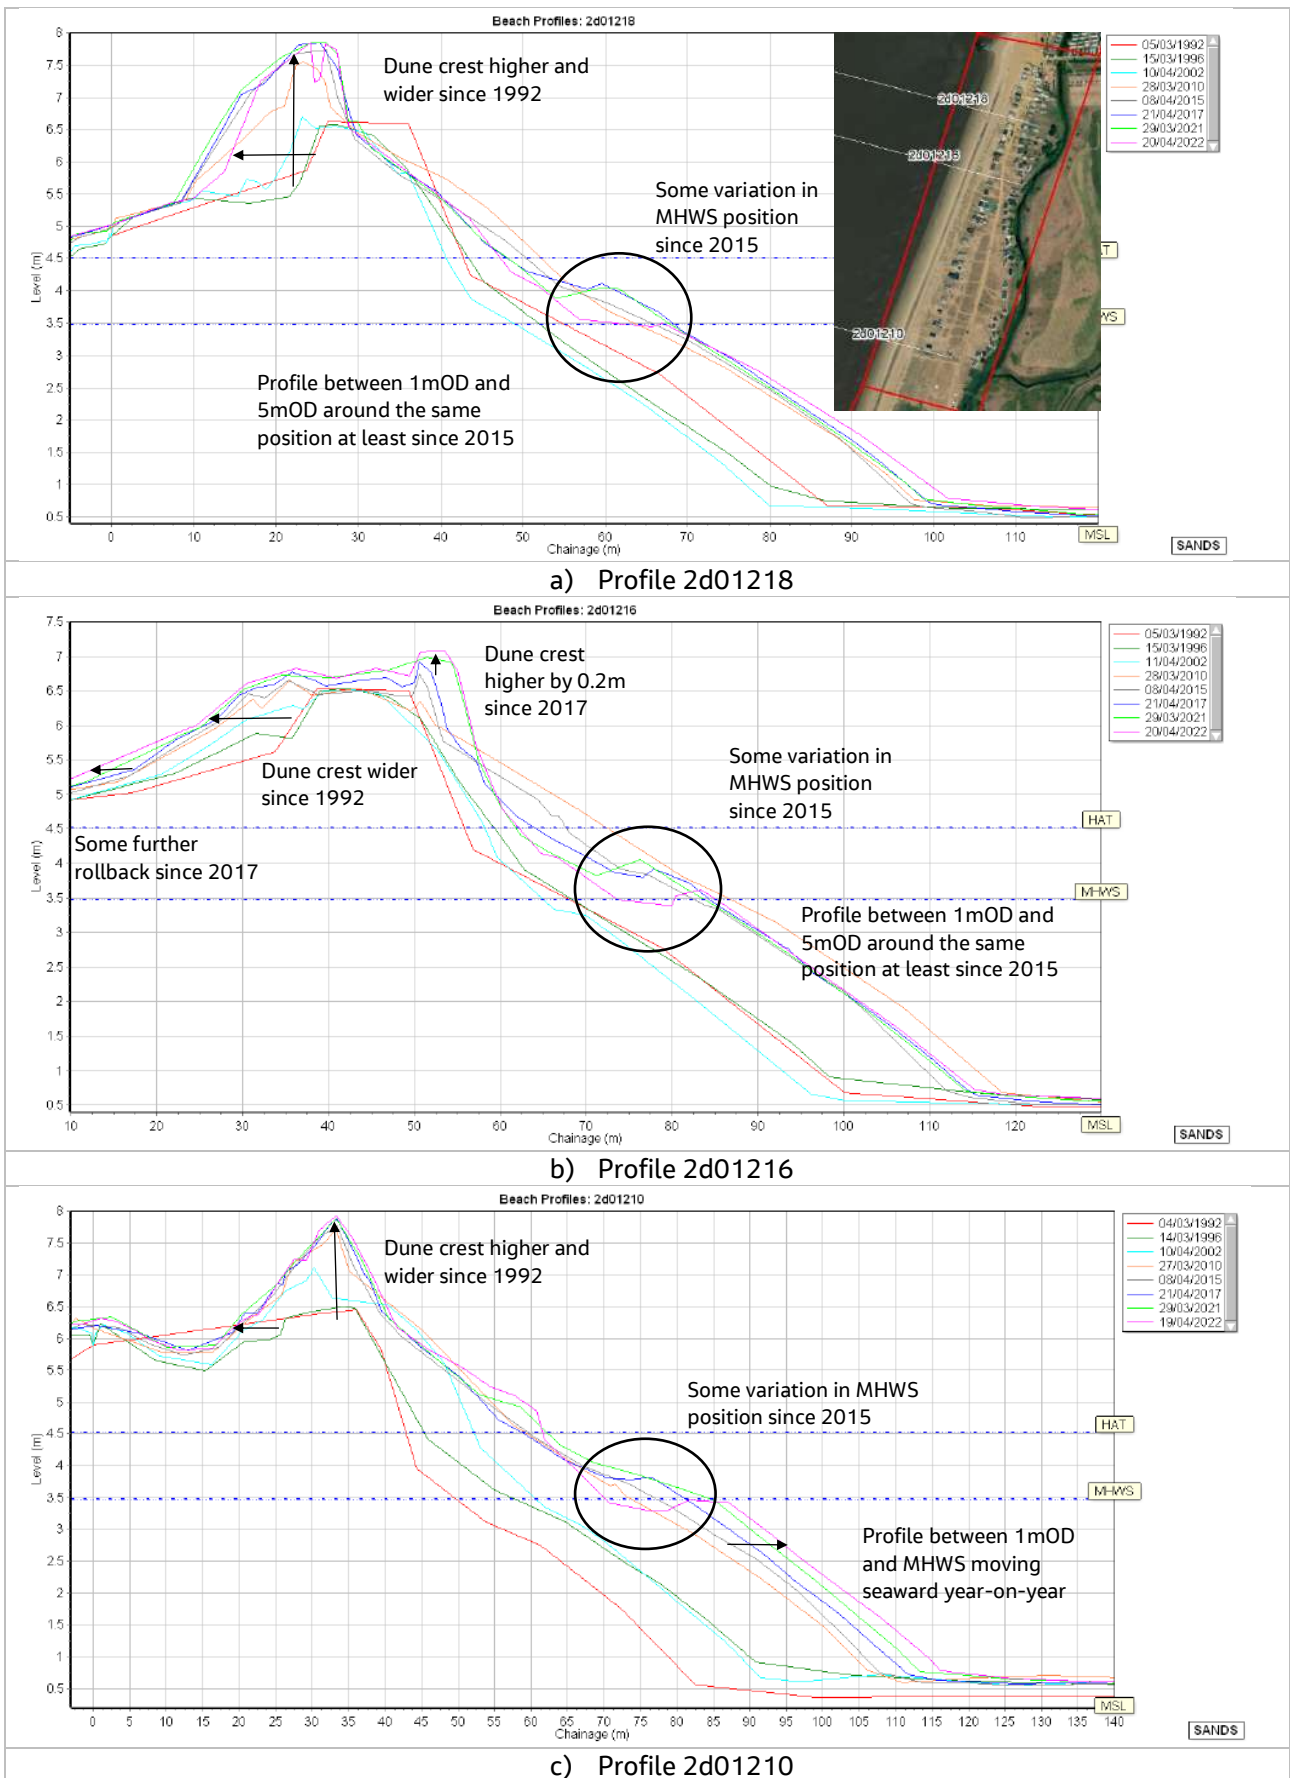
Figure 4-10: Beach profiles a) 2d01218, b) 2d01216, and c) 2d01210 along Zones 6 and 7

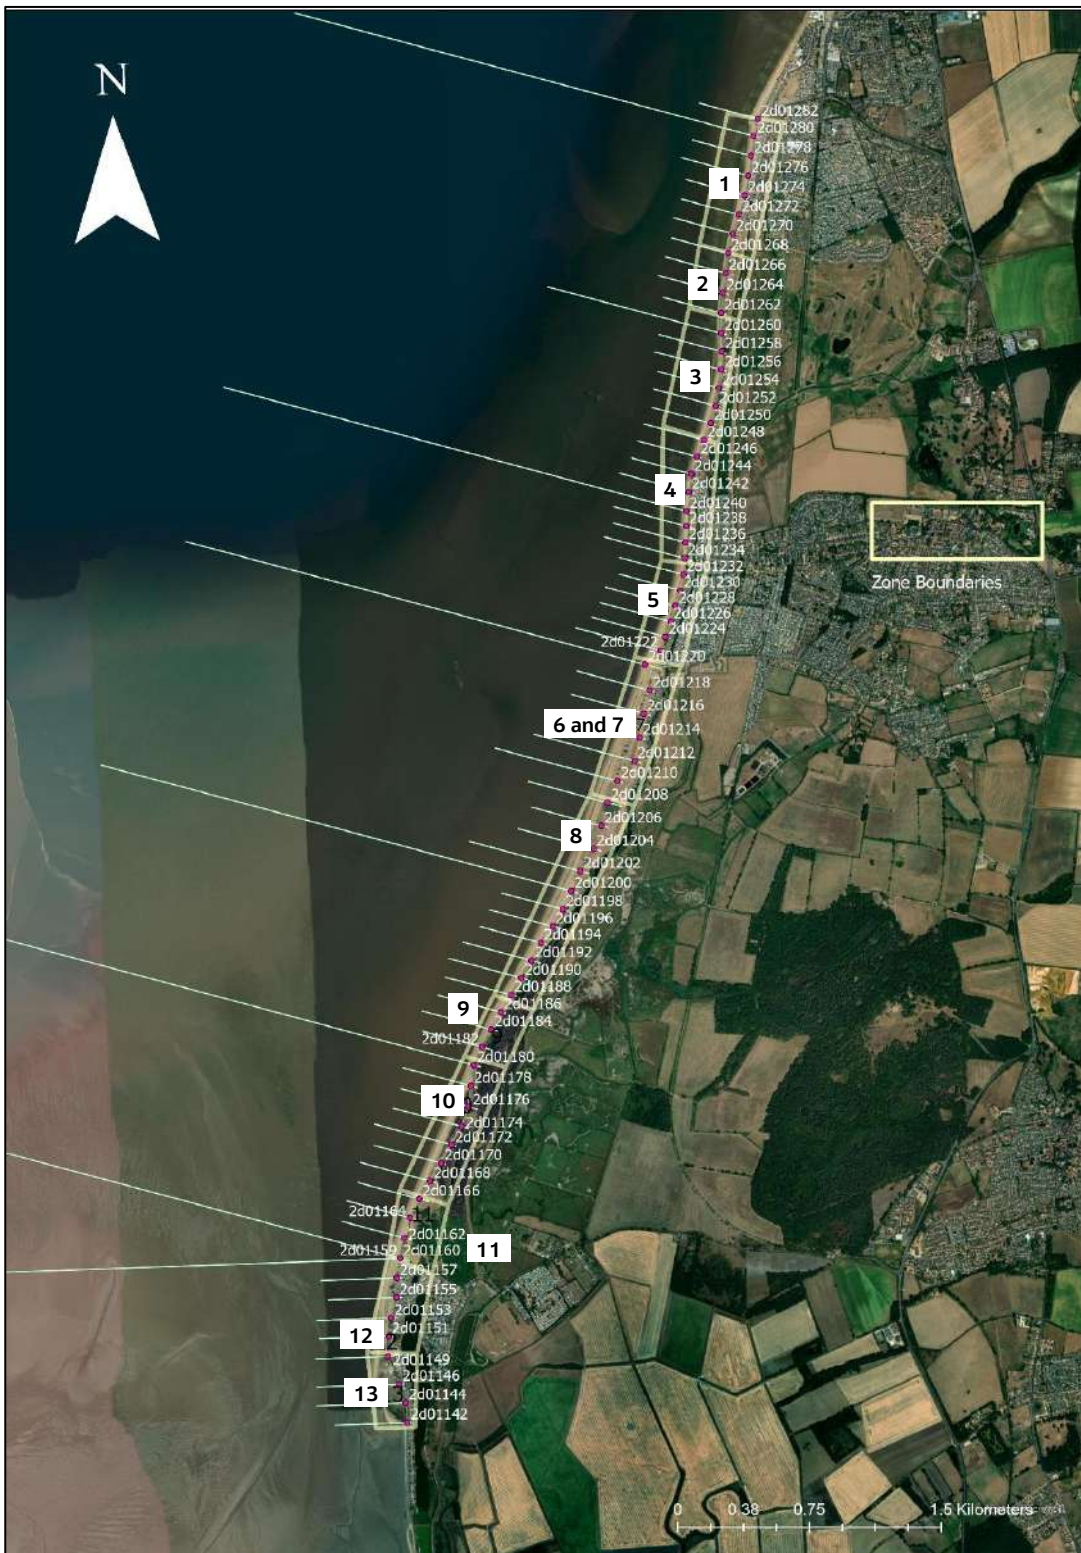
Figure C. 1: Beach profiles and zone boundaries used for analysis along Unit C frontage

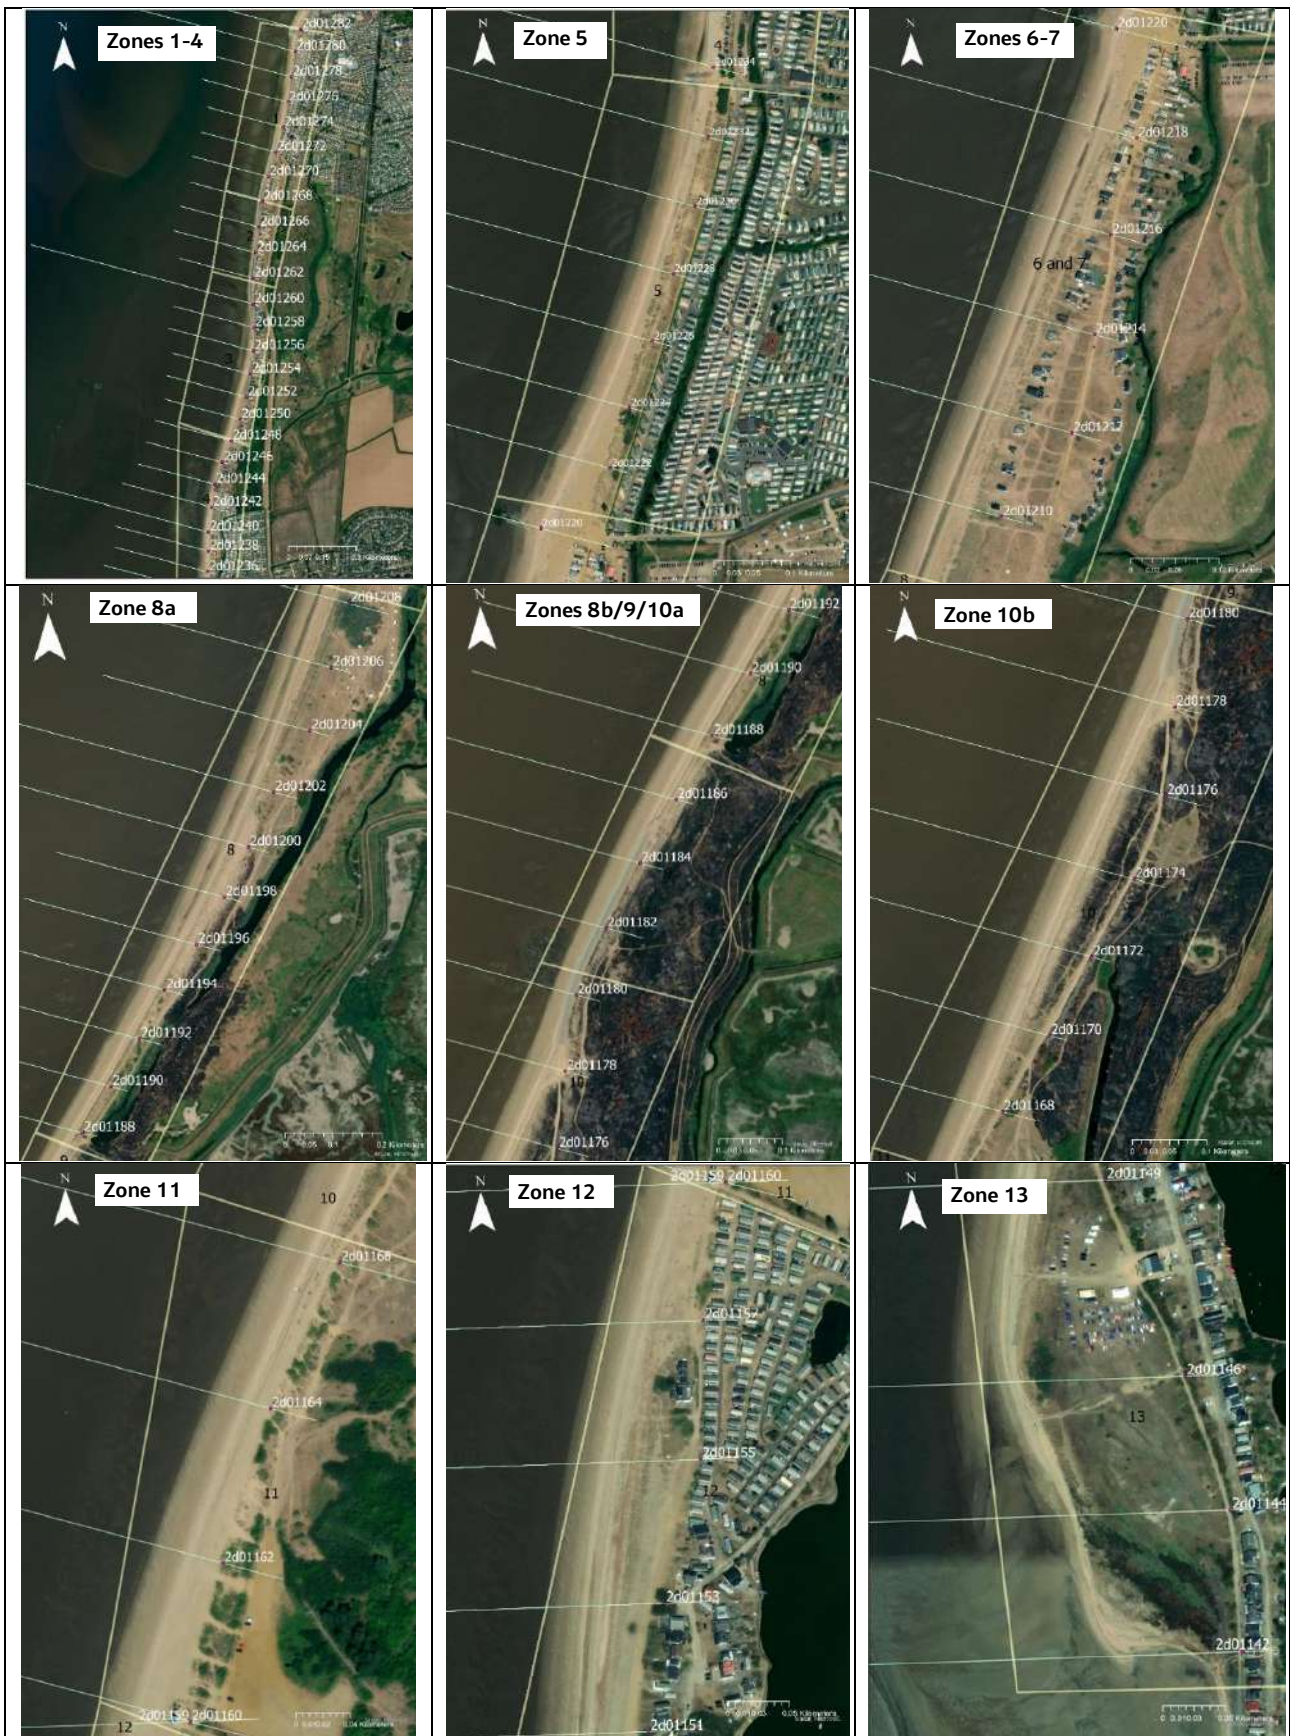
Figure C. 2: Beach profiles split into zone boundaries

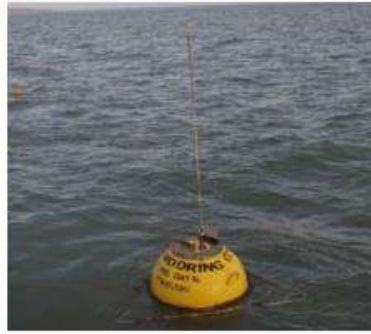
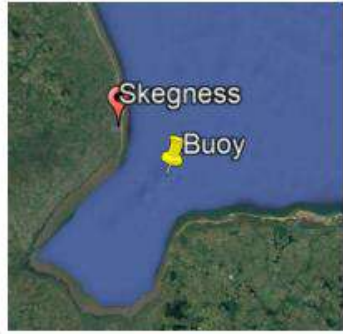
OS	565996 E 354077 N		
WGS84	Latitude: 53° 03.49' N Longitude: 00° 28.53' E		
Instrument type			
Datawell Directional Waverider Mk III			
Water depth	~31m CD	Example buoy in situ. Photo courtesy of Fugro Marine GB Limited	Location of buoy (Google mapping, image ©2019 Landsat / Copernicus)

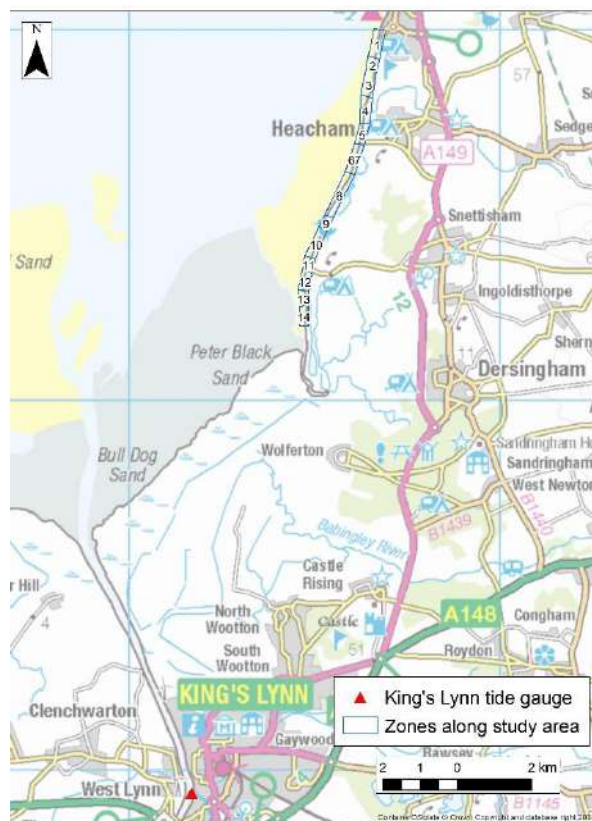
Figure C. 4: Location of the King’s Lynn Tide Gauge

Total water levels (m) were extracted from the King’s Lynn tide gauge (Figure C. 4). Using Mike21 toolbox for tidal analysis, the total water level information was split between astronomical (or predicted) tides and residual (or surges). Since total water level data showed some gaps, the data was queried and only continuous periods longer than 30 days at a time were used in the analysis.

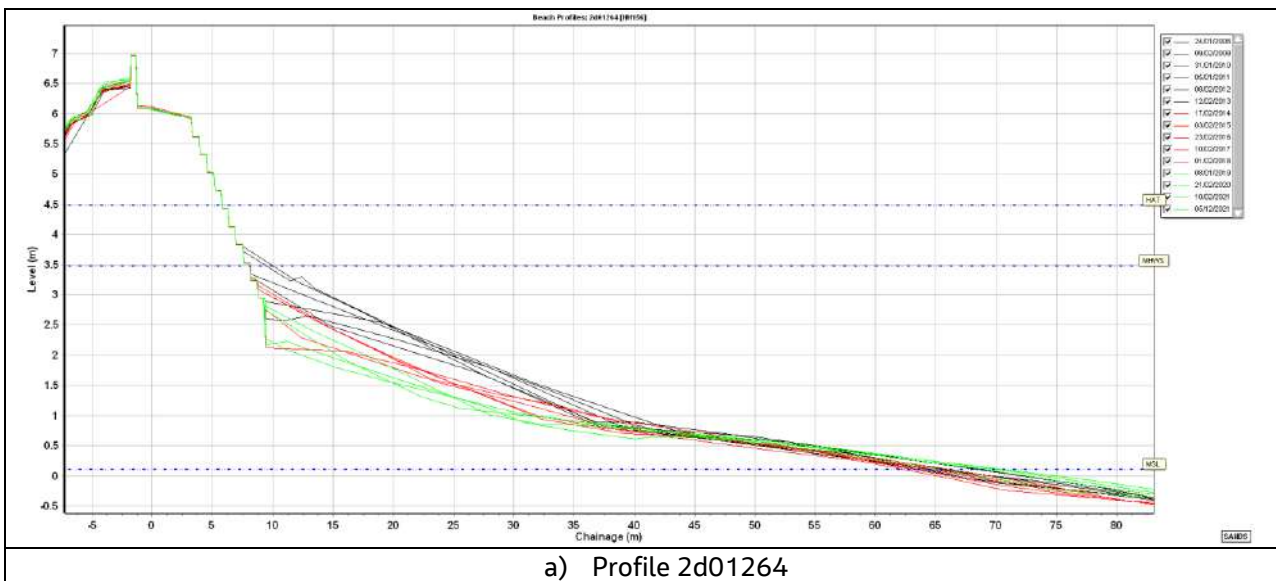
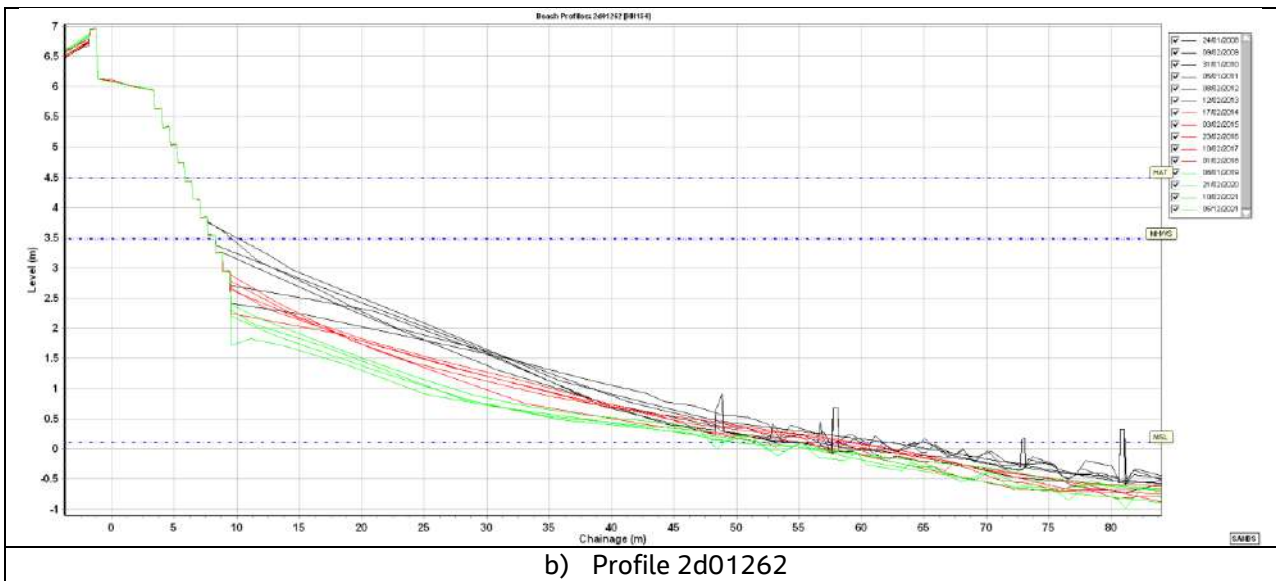
a) Profile 2d01264

Figure C. 9: Examples of profile analysis in Zone 2 showing profile change between 2008-2013 (black line), 2014-2018 (red line) and 2019-2022 (green line) at a) profile 2d01264 and b) 2d01262

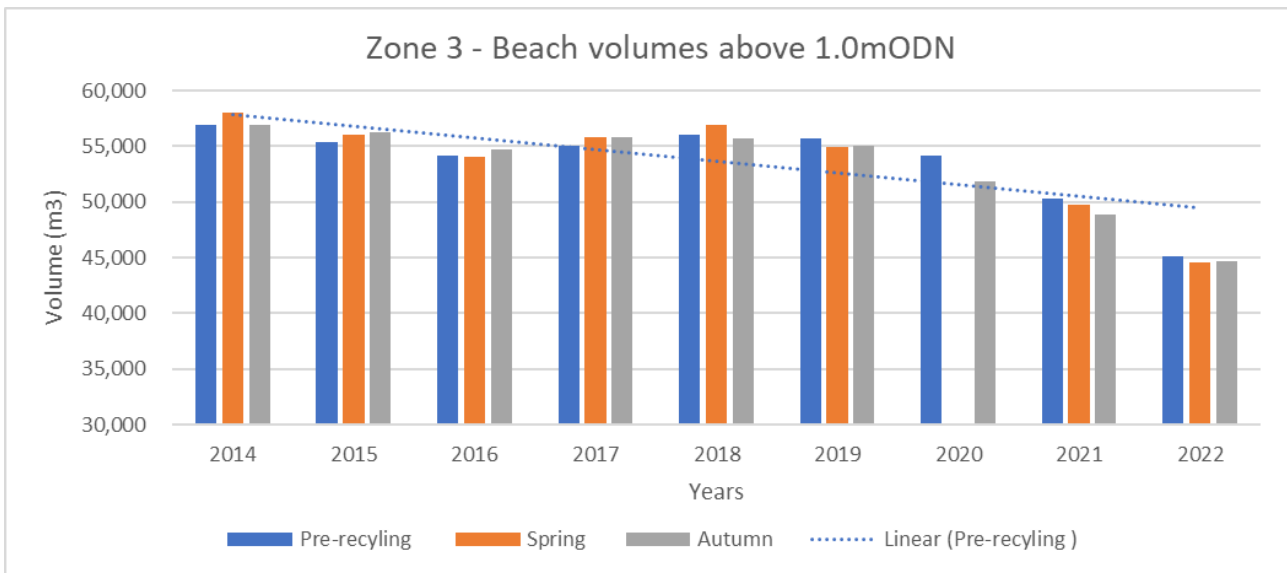
Figure C. 10: Beach volume (m³) above 1.0mODN, calculated for pre-recycling, Spring and Autumn surveys, from 2014 to 2022 in Zone 3

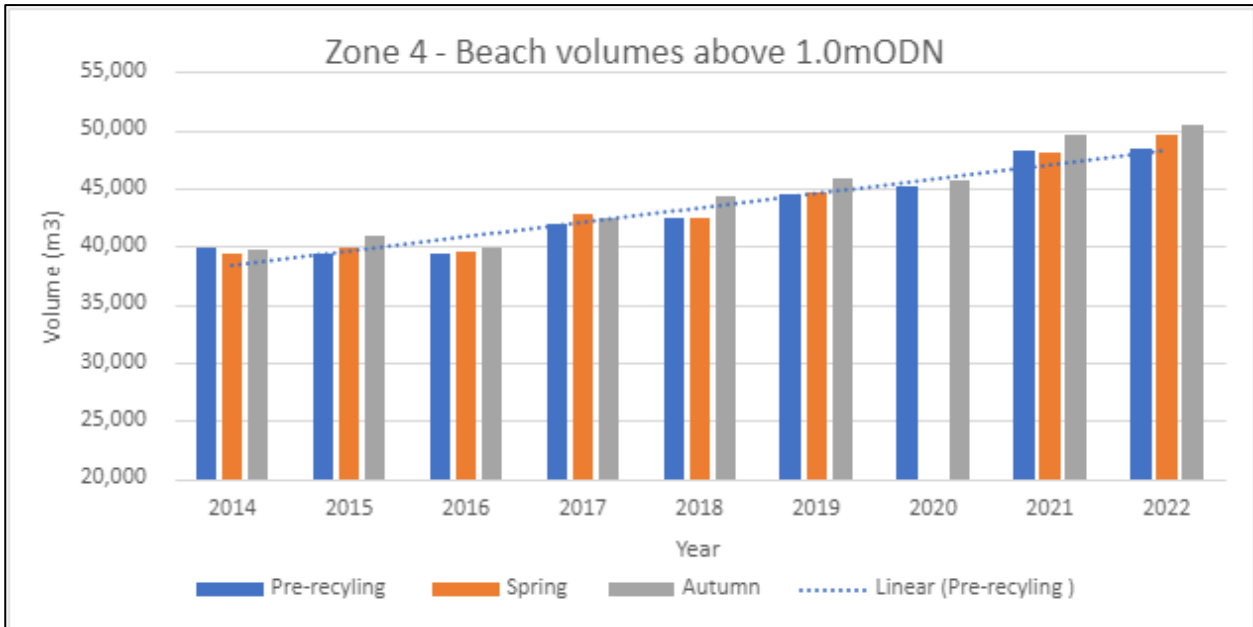
Figure C. 12: Beach volume (m³) above 1.0mODN, calculated from pre-recycling, Spring, and Autumn surveys, from 2014 to 2022 in Zone 4

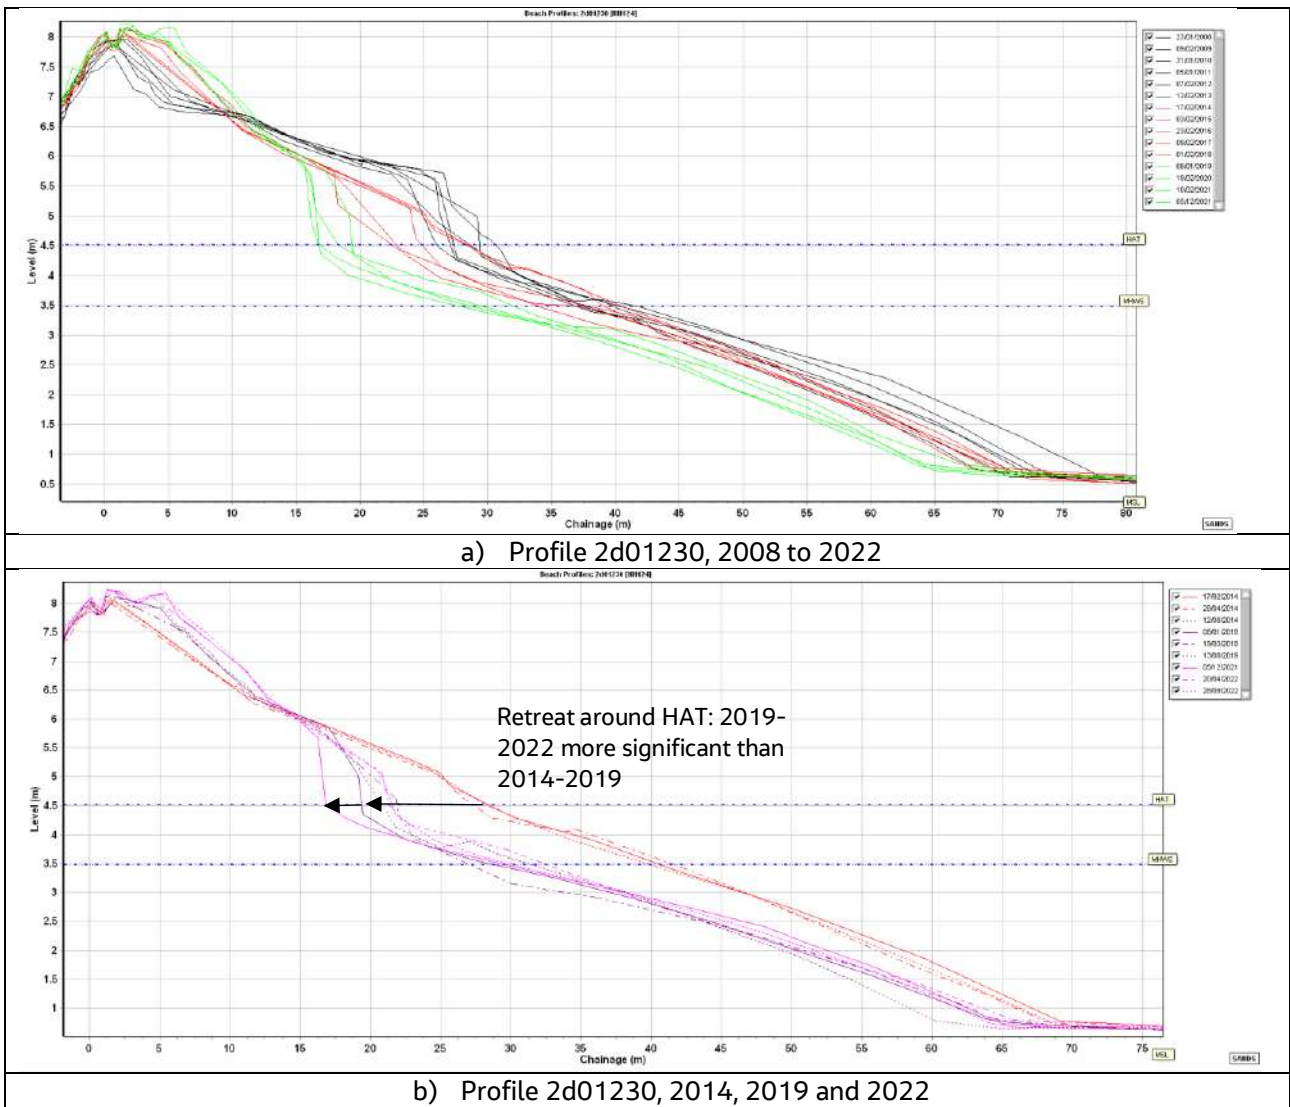
Figure C. 15: Profile 2d01230 in Zone 5 showing profile change (a) between three timeframes: 2008-2013 (black line), 2014-2018 (red line) and 2019-2022 (green line) and (b) between four specific surveys (1998, 2006, 2014, 2022).

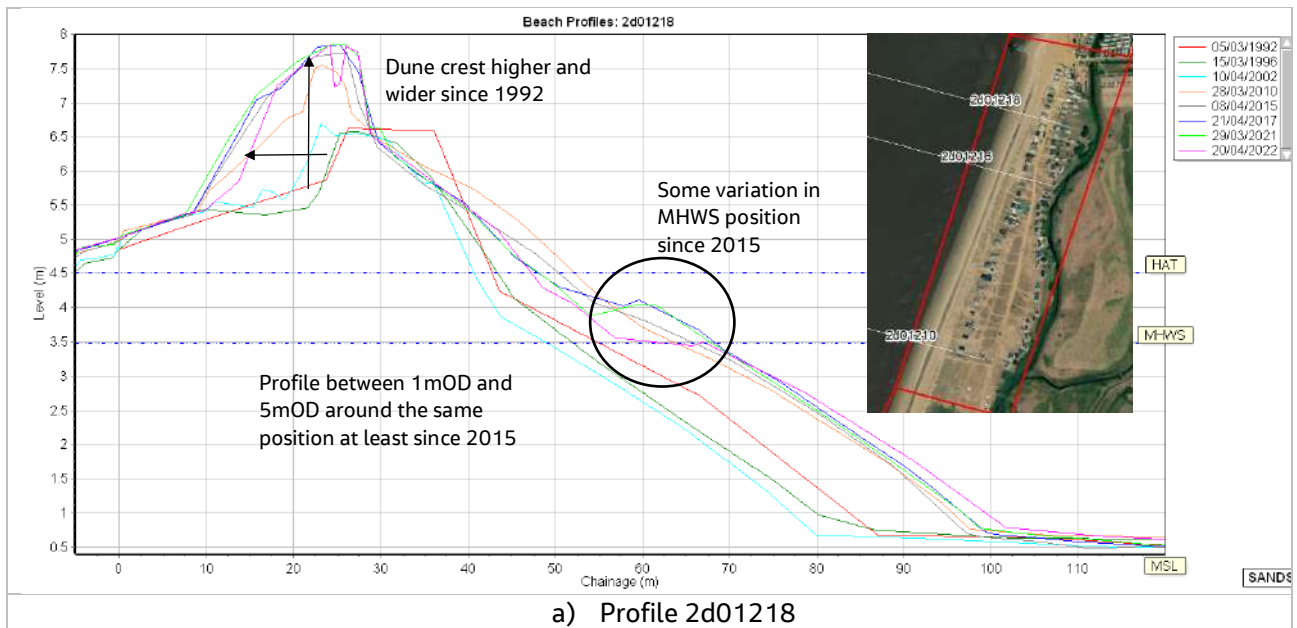
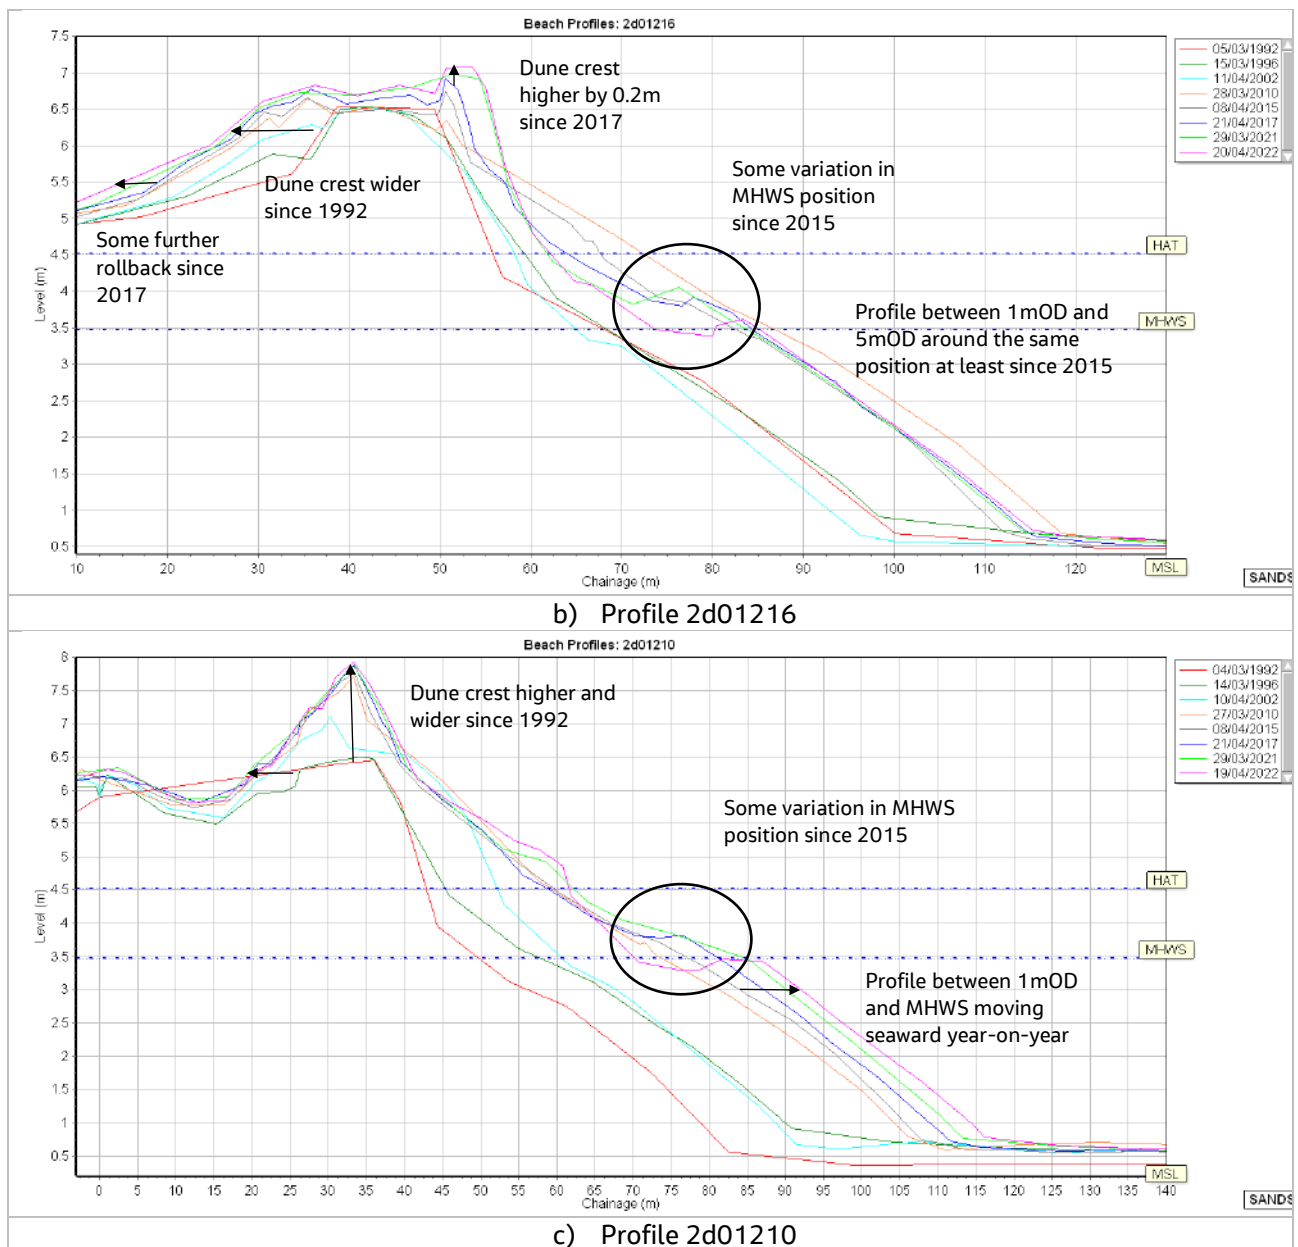
Figure C. 18: Beach profiles a) 2d01218, b) 2d01216, and c) 2d01210 along Zones 6 and 7

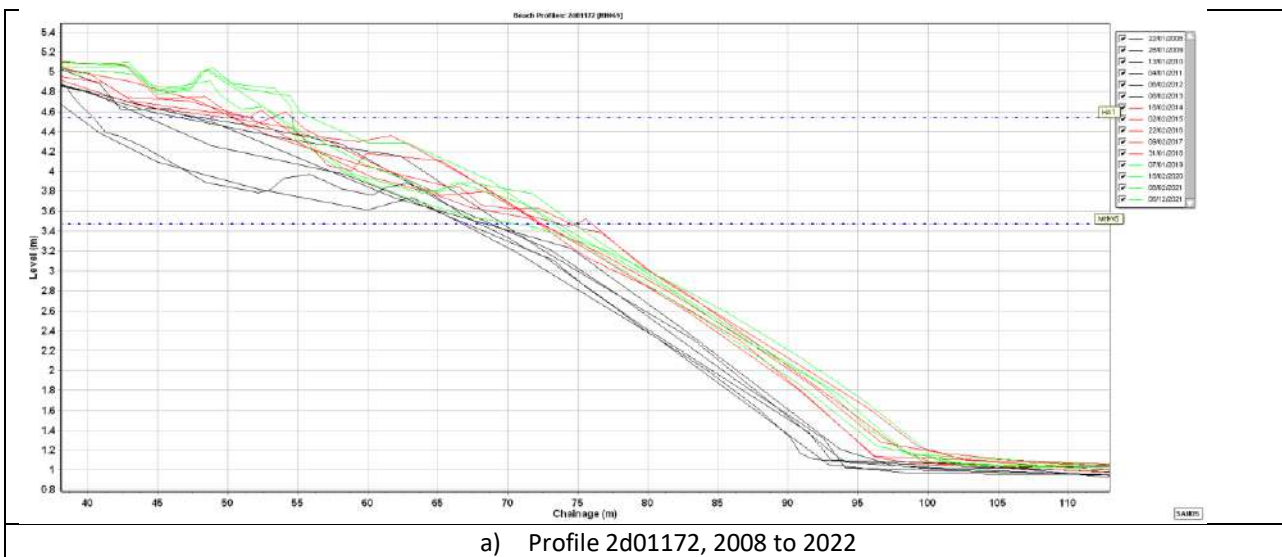
a) Profile 2d01172, 2008 to 2022

Figure C. 26: Profile analysis in Zone 10b, profile 2d01172, showing profile change between a) 2008-2013 (black line), 2014-2018 (red line) and 2019-2022 (green line), and b) between the pre-recycling, Spring and Autumn surveys in 2014, 2019 and 2022.

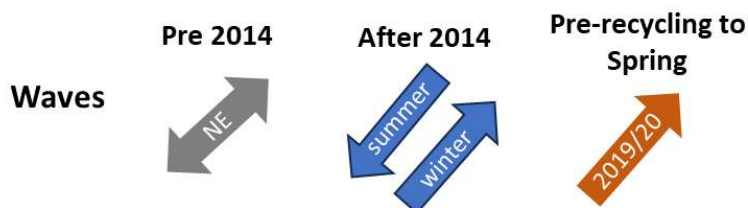
Between pre-recycling and Spring surveys, the period pre-2014 showed that NE waves are slightly more dominant than SW waves, with higher Significant Wave Height (Hs) of around 2-2.5m) from NE. The highest Peak Period (Tp) of around 17s occurred from NE, but Tp from SW also reached up to 14s over this period (NE-SW Tps were similar in frequency).

In addition, the winter periods pre-2014 had a similar NE-SW wave frequency, with a slightly more NE dominance. The summer period dominance was varied year on year between NE and SW.

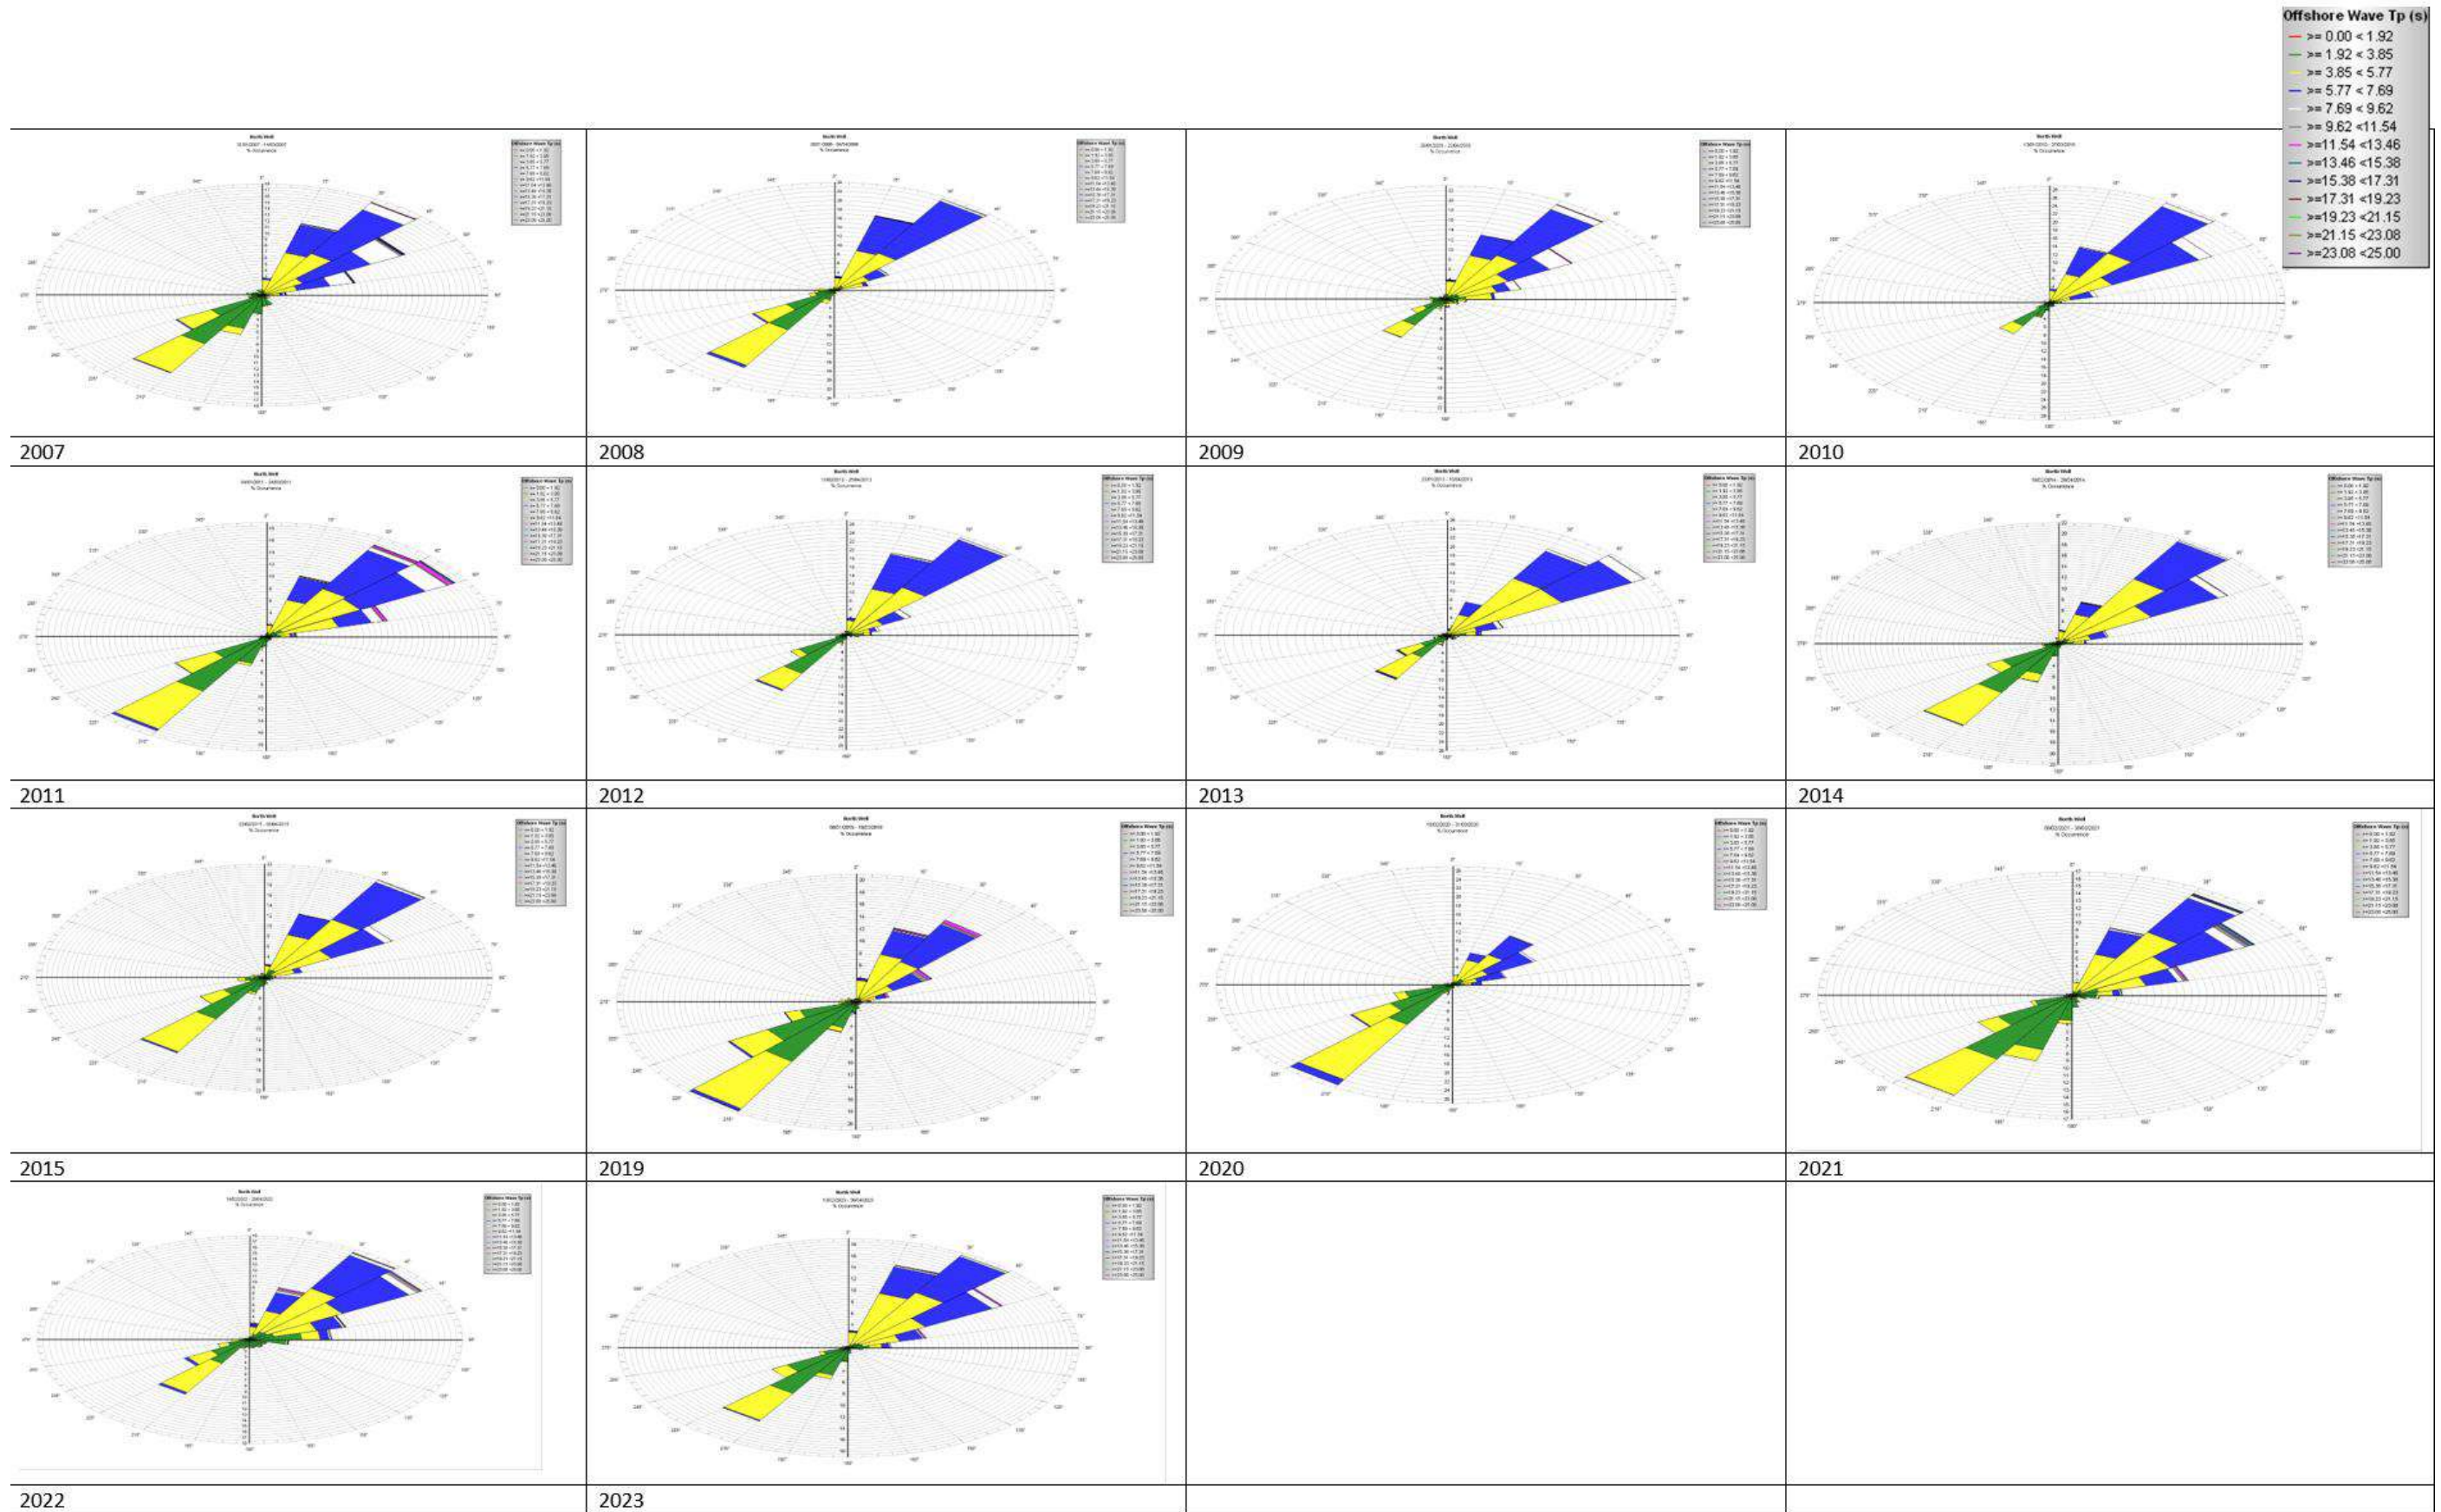
Figure C. 38: Peak Wave Period (Tp) (s) from 2007 to 2023 (excluding 2016, 2017 and 2018 due to lack of data) between the pre-recycling and Spring survey dates specific to each year.
