Hunstanton Concrete Groyne Removal Works

Background:

Current Management of Groynes:

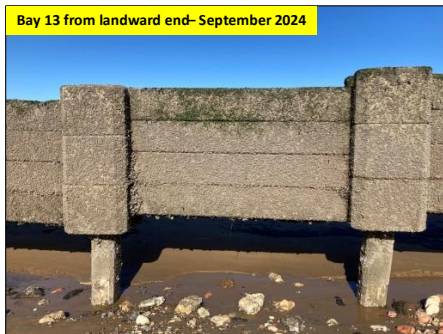
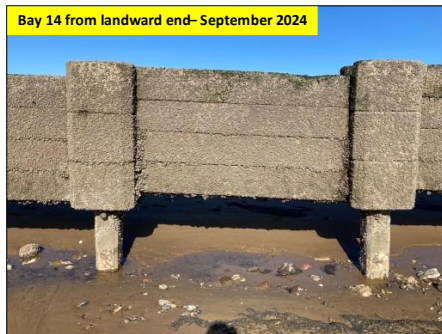
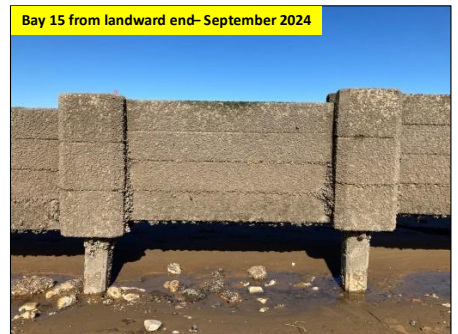
Concrete Groyne 7

A recent health and safety inspection of the concrete groynes identified that some health and safety removal works were required to concrete groynes 7, 8 and 9. This involved removing some of the horizontal concrete planks from these groynes. Once removed, these planks will not be reinstated. The Borough Council appointed Southbay Civil Engineering to undertake these health and safety removal works, which were completed between Monday 21st October and Wednesday 23rd October 2024.

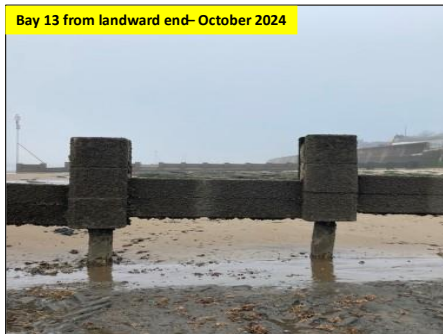
Top two horizontal concrete planks removed

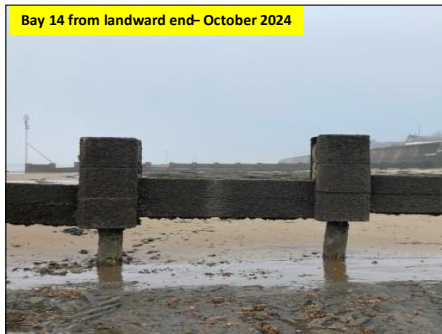
Top two horizontal concrete planks removed

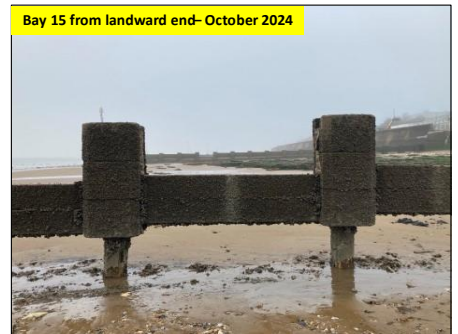
Top two horizontal concrete planks removed

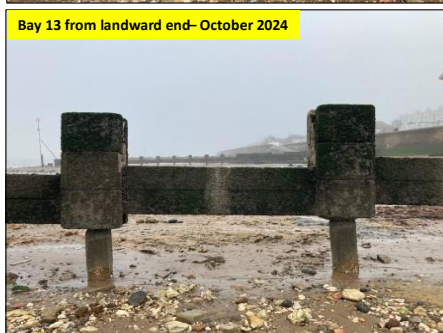
Concrete Groyne 8

Top two horizontal concrete planks removed

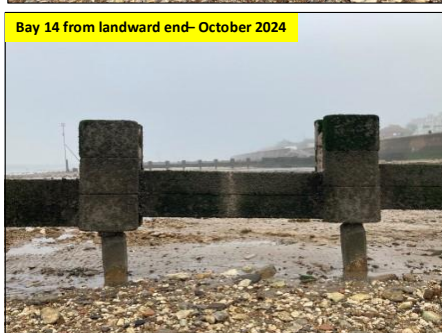
Top two horizontal concrete planks removed

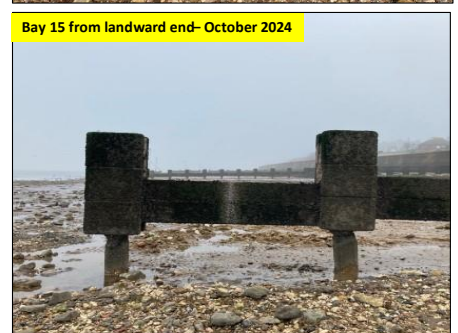
Top two horizontal concrete planks removed

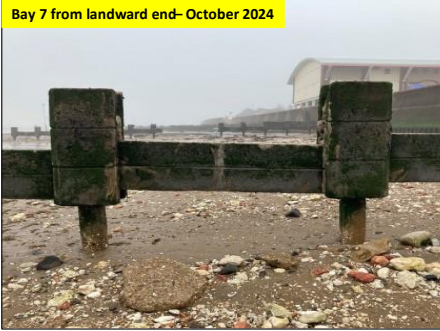
Bay 7 from landward end- October 2024

Top two horizontal concrete planks removed

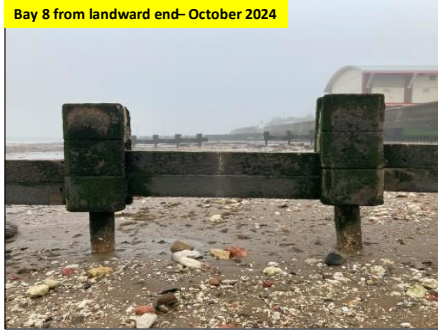
Bay 8 from landward end- October 2024

Top two horizontal concrete planks removed

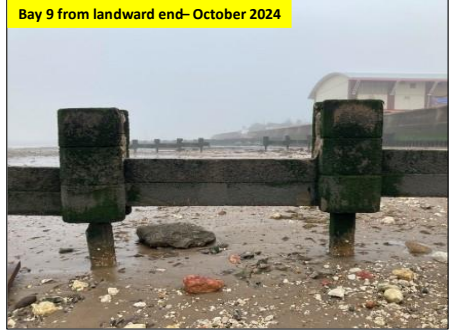
Bay 9 from landward end- October 2024

Top two horizontal concrete planks removed
