#### THE WASH EAST COASTAL MANAGEMENT STRATEGY STAKEHOLDERS FORUM

#### Minutes of the Meeting of the above held on Thursday, 1st August, 2024 at 10.00 am in the Room at Valentine Road, Hunstanton and on Microsoft Teams

# WECMS Stakeholder

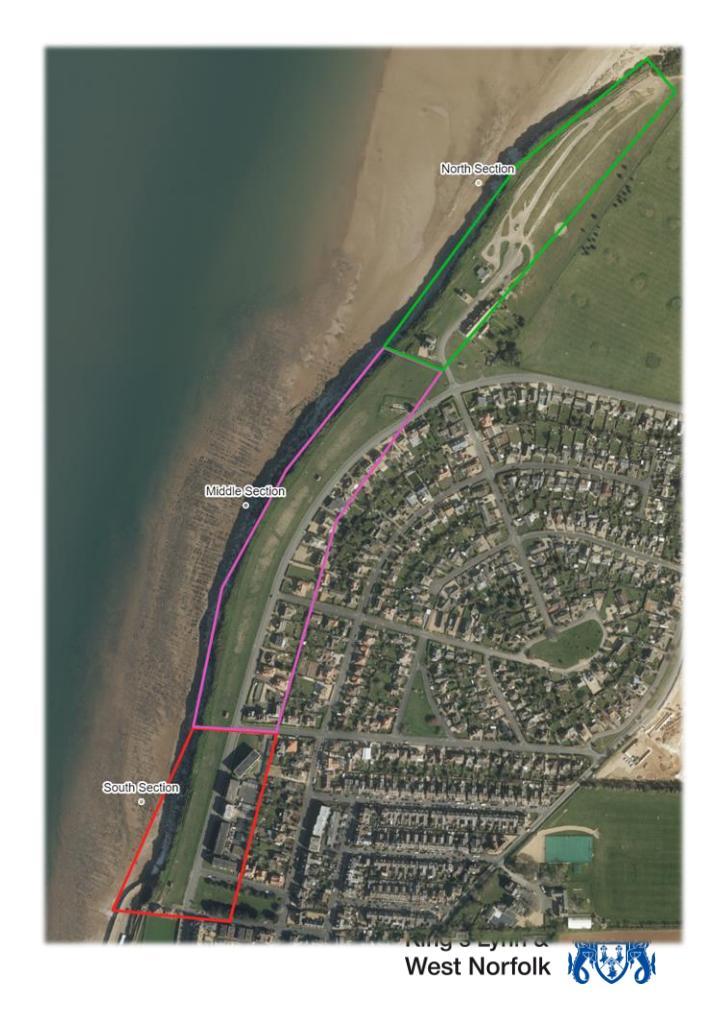
- Survey completed April 2023.
- Final report received & will go onto website this week.
- Key findings are:
  - $\exists$  Mean rate of erosion is similar to previous years,
  - $_{\overrightarrow{N}}$  at 12.5cm per year.
    - North section of cliffs, between the lighthouse and coastguard lookout, remains the most active in terms of erosion.
    - Beach levels have continued to lower across the length of the cliffs, dropping by 2.5m since 2010.

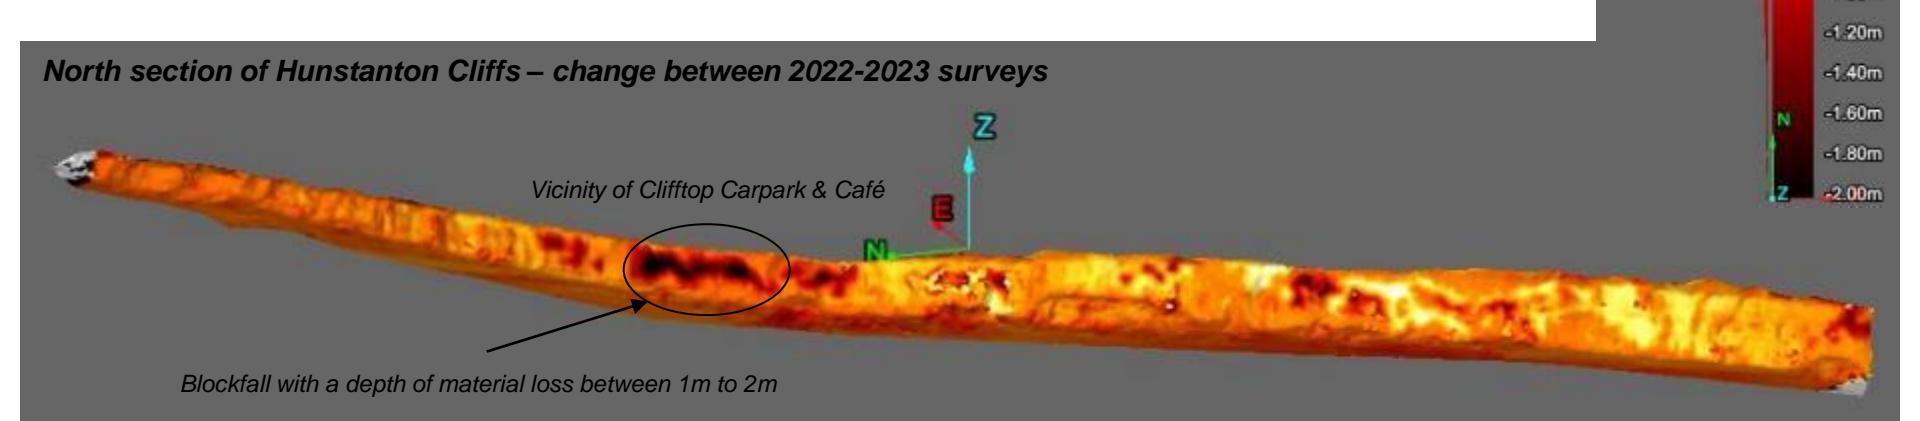
- No significant cliff falls occurred between 2022 and 2023.
- 3 minor cliff falls occurred between 2022-2023 (1 in each section of the cliffs), with a depth between 0.5m and 2m.
- Erosion observed is consistent with previous years and predictions of the Hunstanton Coastal Management Plan.

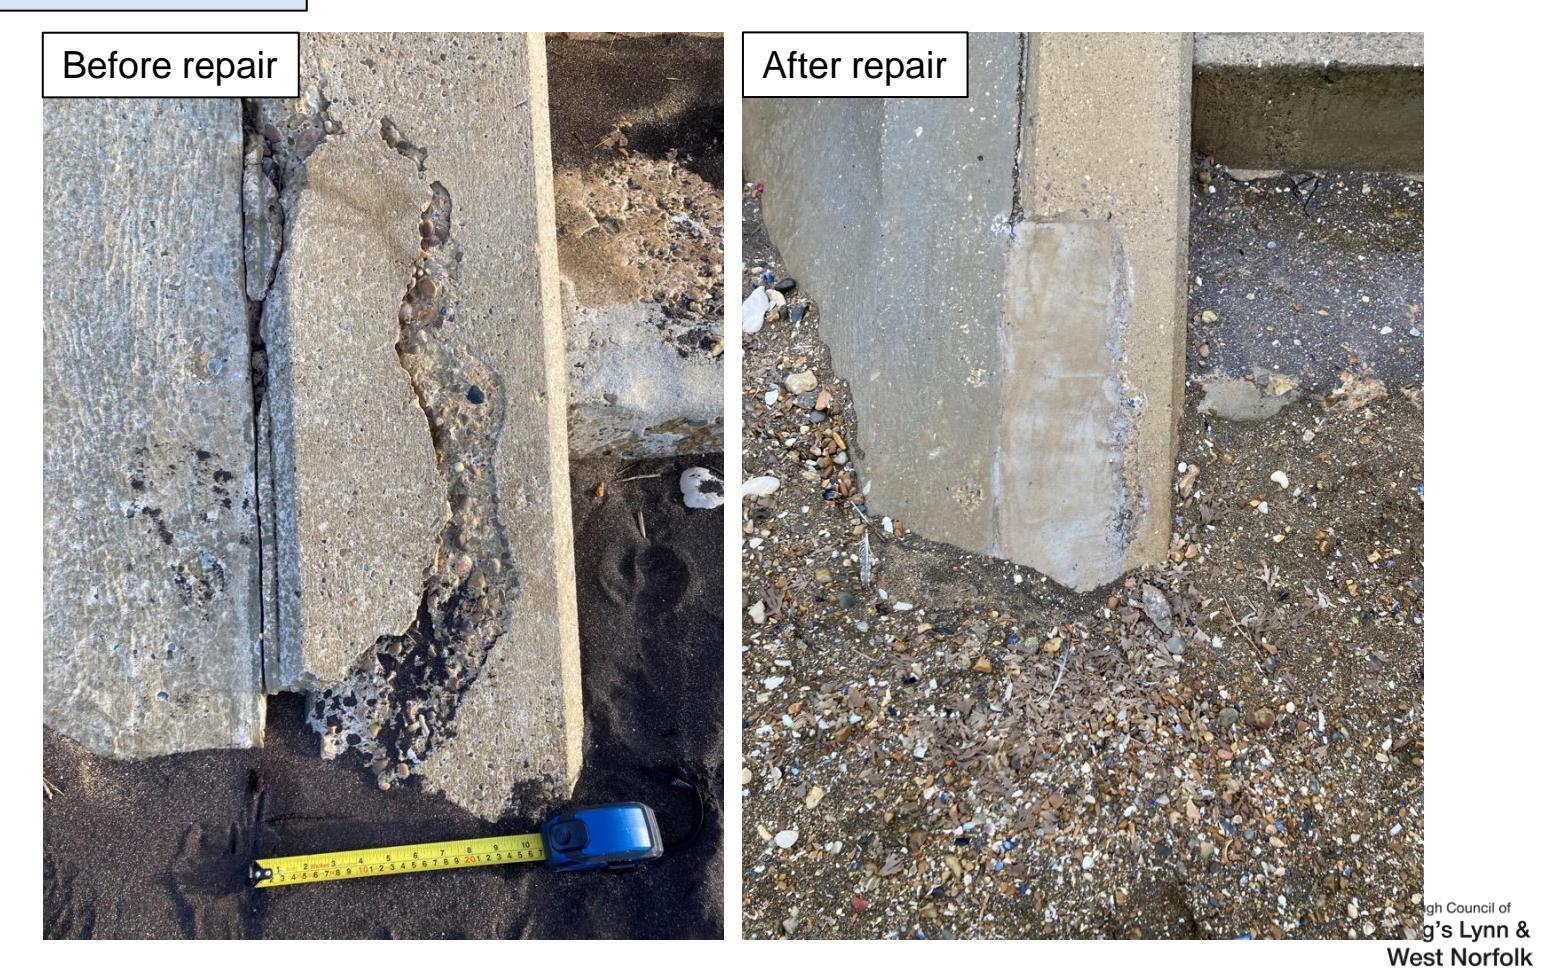
## Seawall concrete patch repair

- Replacement of sealant for 56 joints on the wavereturn wall
- Replacement of 6 mortar joints on the seawall
- 5 concrete patch repairs to the seawall
- 5 concrete patch repairs to the wave-return wall

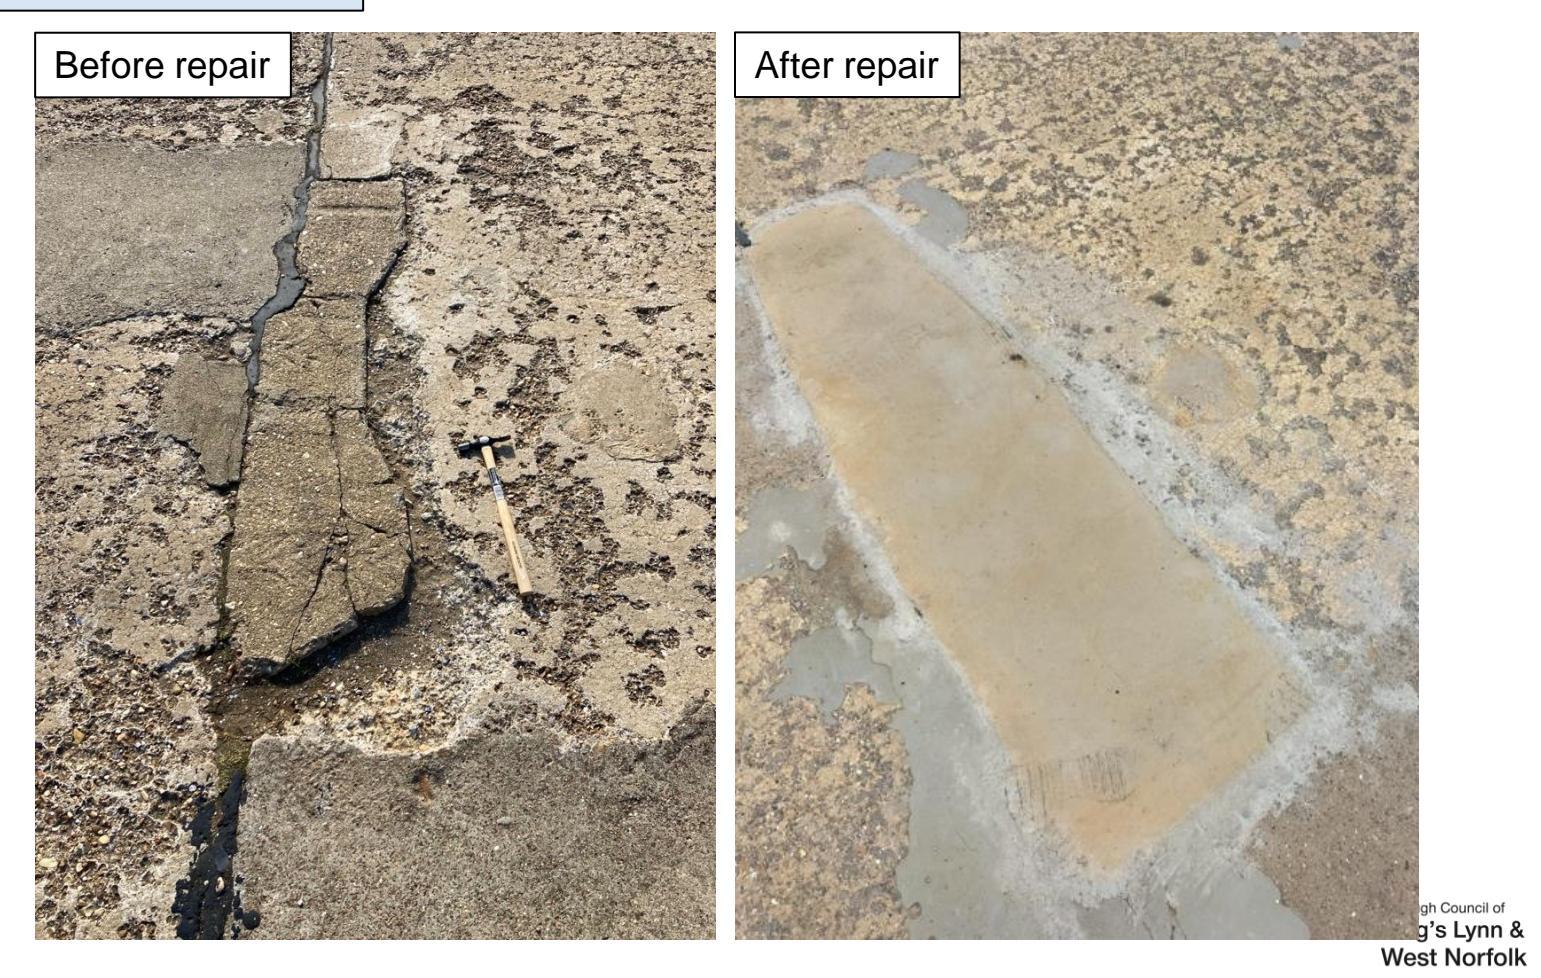
## Promenade concrete patch repair

- Replacement of sealant for 14 joints on the promenade and slipways
- 3 concrete patch repairs to the promenade
- 5 concrete patch repairs to slipways
- · 2 concrete repairs to beach access steps

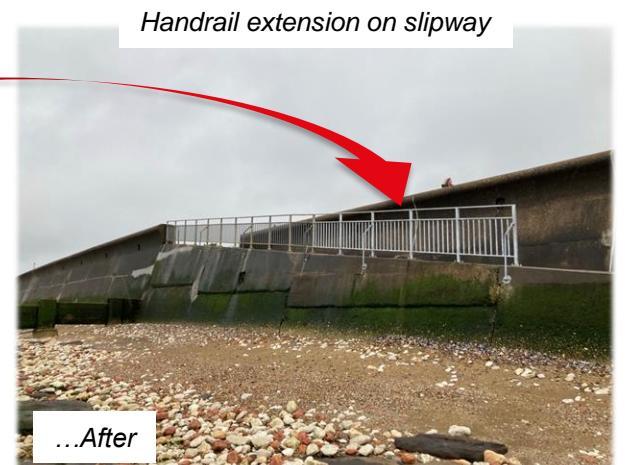
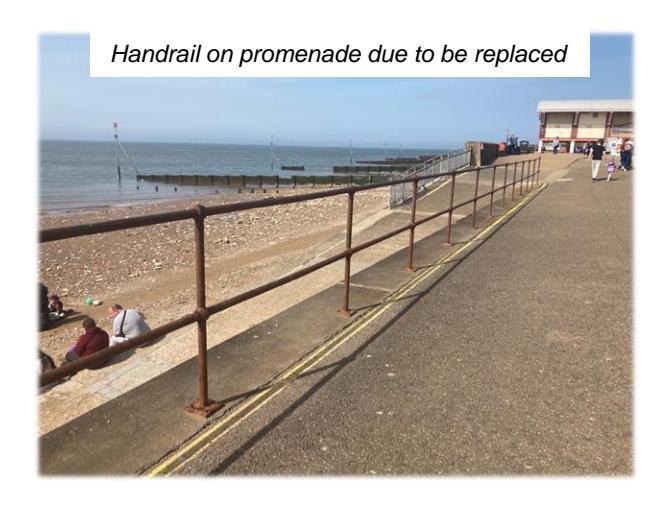
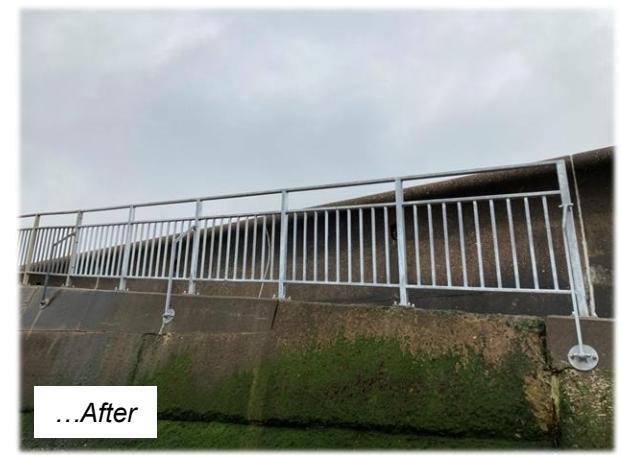
- Handrail extension to sailing club slipway completed in July 2024.
- Replacement of handrail on promenade by rock shop will be completed in September.
- Health and safety works
   N

Area where extension

of handrails is required

Handrails installed in

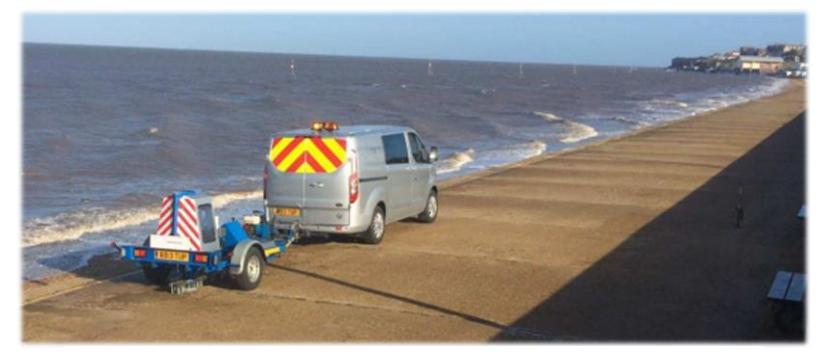
Falling weight deflectometer survey being undertaken in 2015

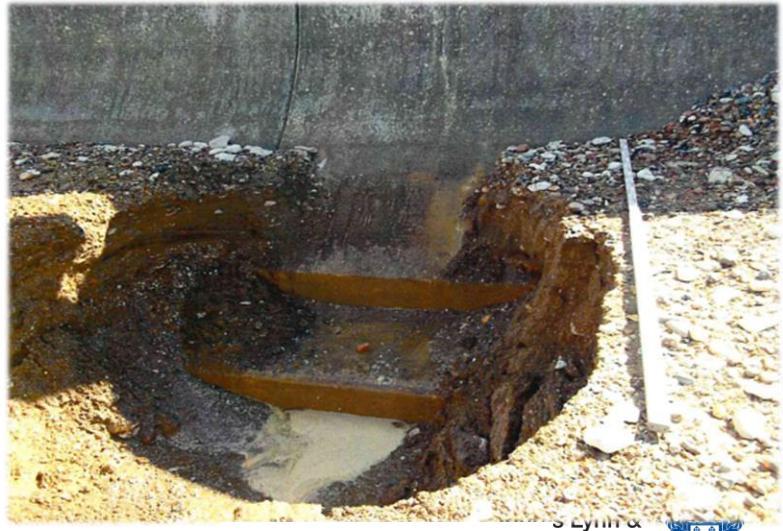
Trial pit undertaken in 2012 Norfolk

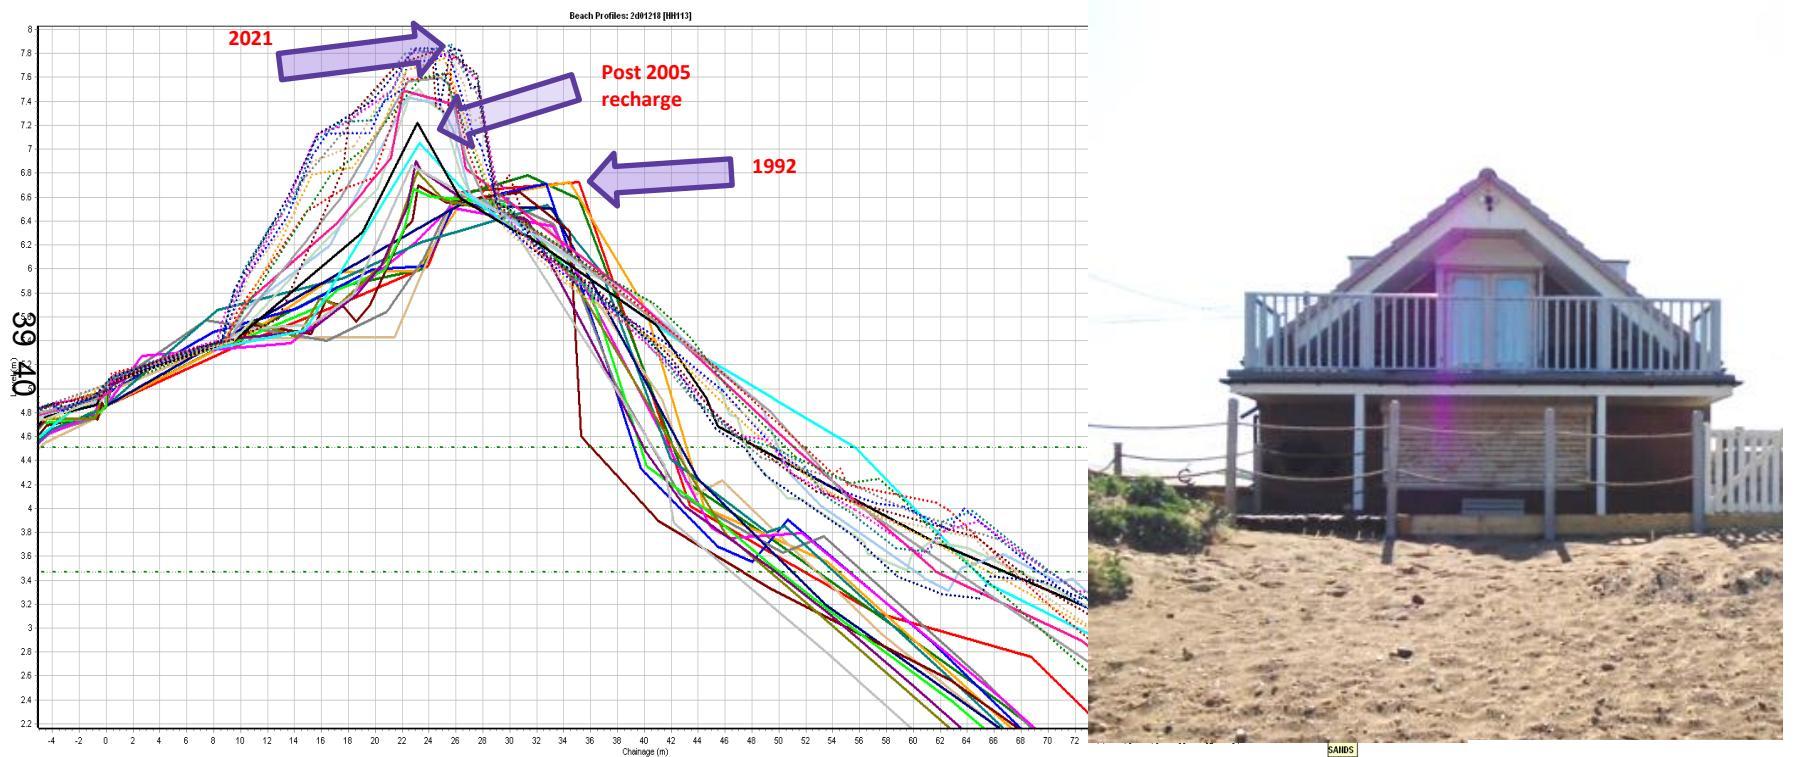
1992-2021 close-up of dune crest

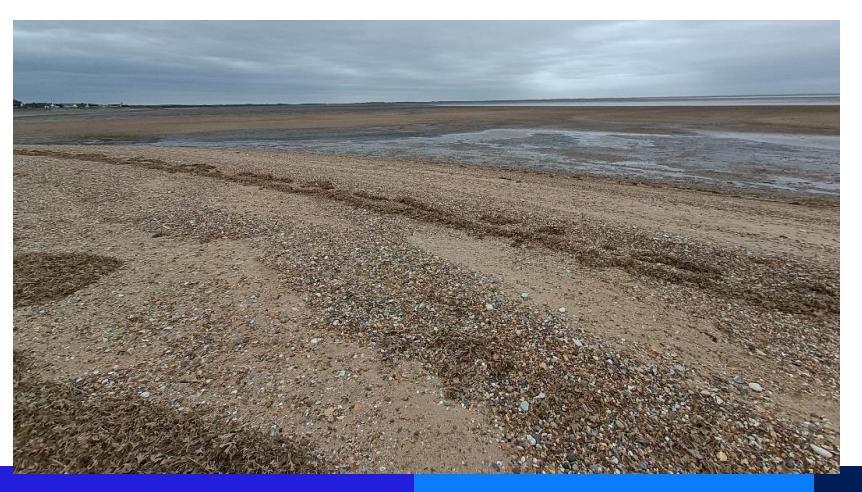
Following extraction of beach material there is recovery of beach volumes by Autumn (dark blue arrows) followed by further accumulation of material prerecycling (light blue arrows)

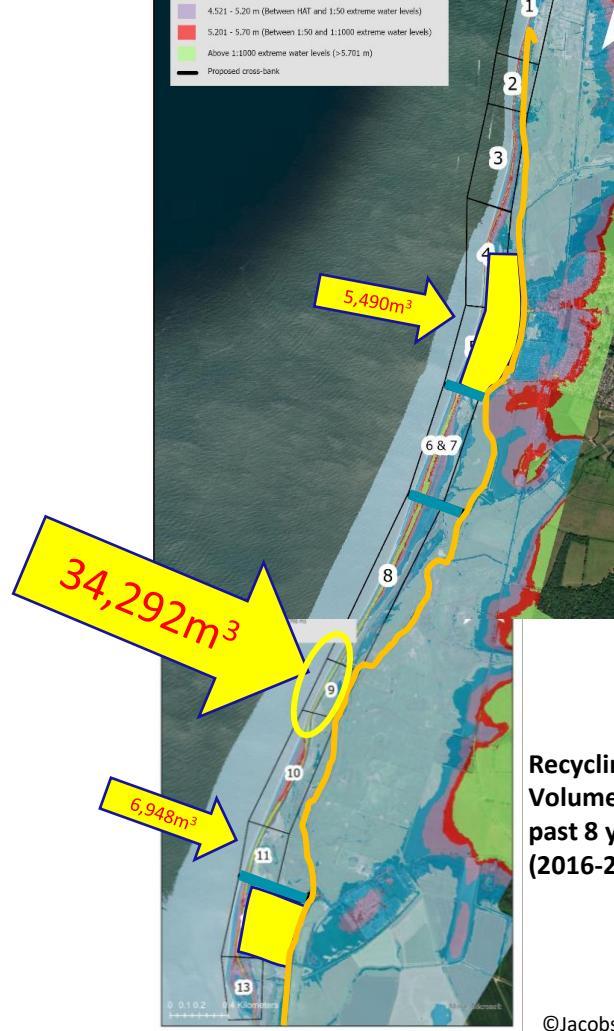
Recycling Volumes over past 8 years (2016-2023)

Heacham				Heacham Dam			Shepherds Port			
Year	Zone 1	Zone 2	Zone 3	Zone 4	Zone 5	Zone 6	Zone 7	Zone 8	Zone 9	Zone	Zone	Zone	Zone	Zone
	2.000			442	4 5 5 4			2.5.07			- 11	12	14	15
2012	2,090	0	0	143	1,551	0	0	3,597	0	0	0	0	0	0
2013	2,970	0	0	0	1,518	0	0	2,321	0	0	0	0	0	0
2014	0	0	0	0	0	0	0	2,988	1,900	1010	1,720	165	630	0
2015	2,233	U	U	0	0	0	0	0	176	44	0	0	0	0
2016	0	0	0	0	488	488	0	2,240	0	420	0	0	0	0
2017	345	0	0	0	480	0	0	3,915	0	855	480	0	0	0
2018	0	0	0	0	294	0	0	5,432	266	266	280	0	0	0
2019	<u> </u>	0	0	0	1,134	0	0	4,004	105	105	2,240	0	42	0
2020	20	0	0	0	1,302	0	0	3,780	84	84	490	0	28	0
2021	0	0	0	0	588	0	0	3,556	210	210	1,456	0	28	0
2022	0	0	0	0	1,120	0	0	3,262	623	623	0	0	140	0
2023	0	0	0	0	84	0	0	3,486	273	273	2,002	0	252	0
